Series 2.25 engine water pump replacement.

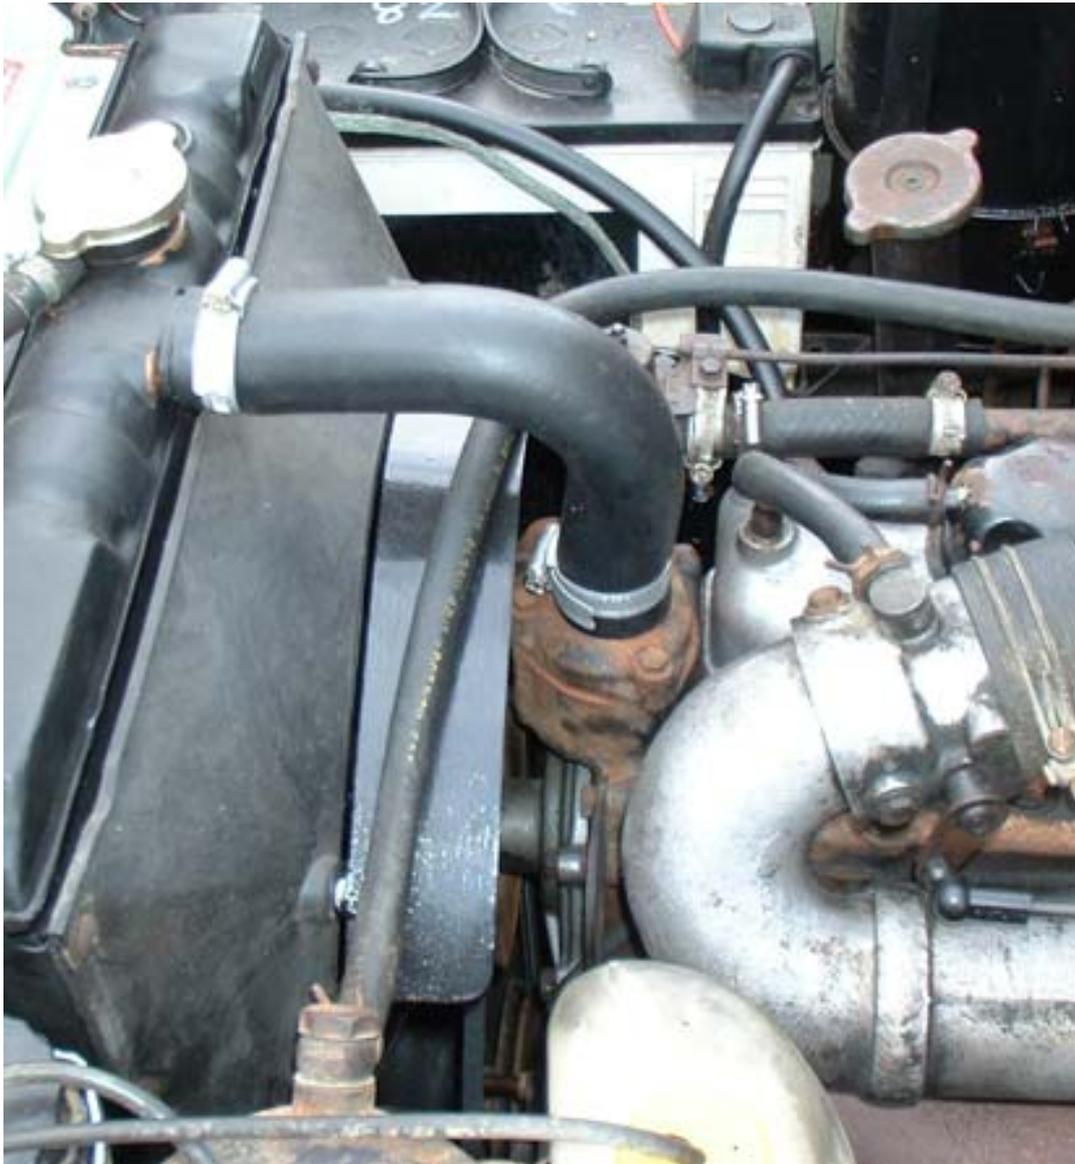
This first photograph shows the radiator and shroud fitted to a 2.25 diesel

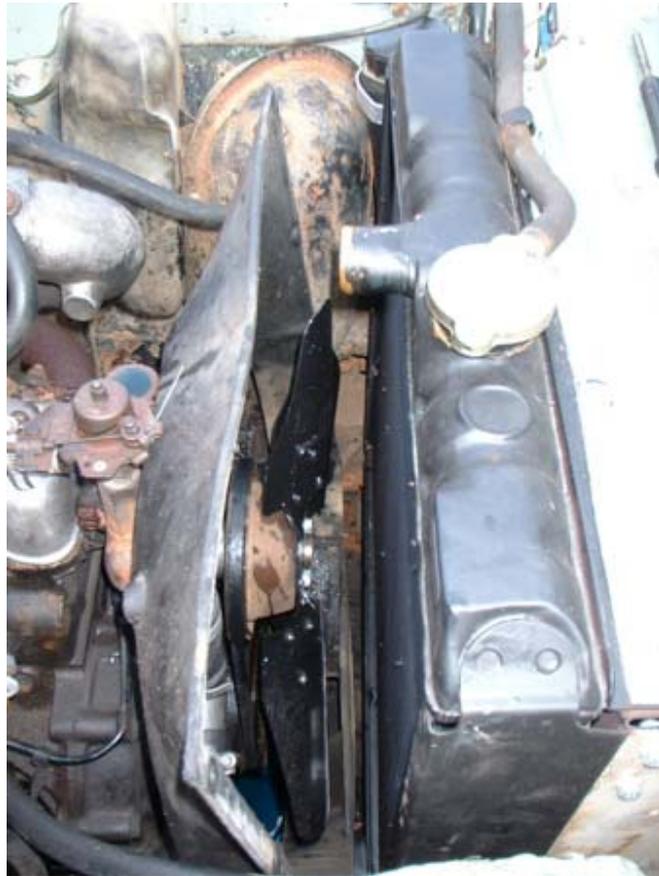
Now that access is a bit easier (and having already loosened the two bolts under the alternator), loosen the top (adjustment) fitting and remove the fan/alternator belt. Then undo the screws holding the plastic cowl to the radiator and push it over the pump and fan assembly as in the next photo.

It isn't necessary to remove the radiator to access the pump, now the cowl is pushed back you can get at the four bolts (3/4") holding the fan and pulley assembly to the water pump body. Now you can remove the cowl from the engine bay. And you can also see why they get left off!

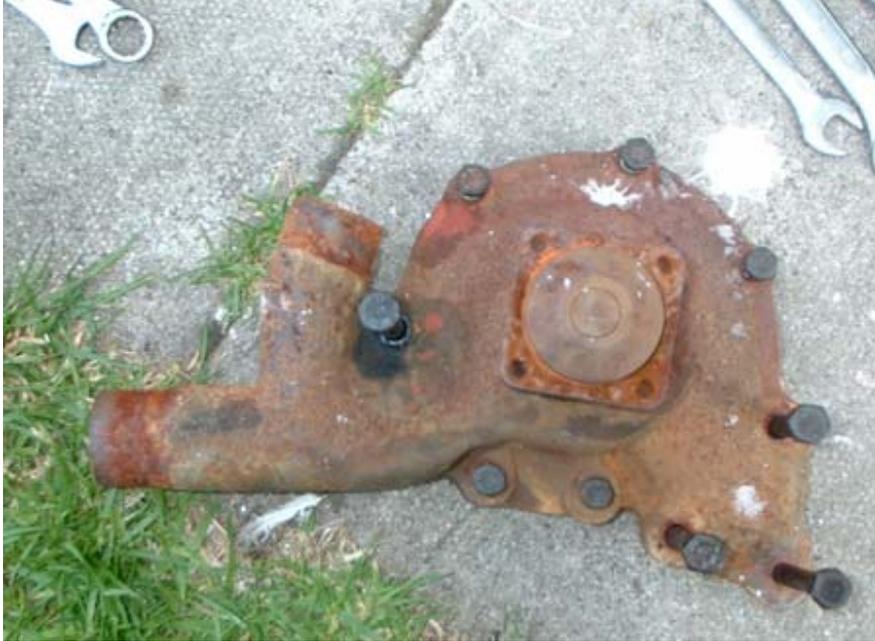
There are different sizes and lengths of bolts holding the pump to the engine, and the simplest way to remember where they go when you remove them is to place them in the corresponding holes in the new pump. Then you can put them in the old pump body once you are ready to fit the new one. I had an old pump lying around (as you do...🤔)

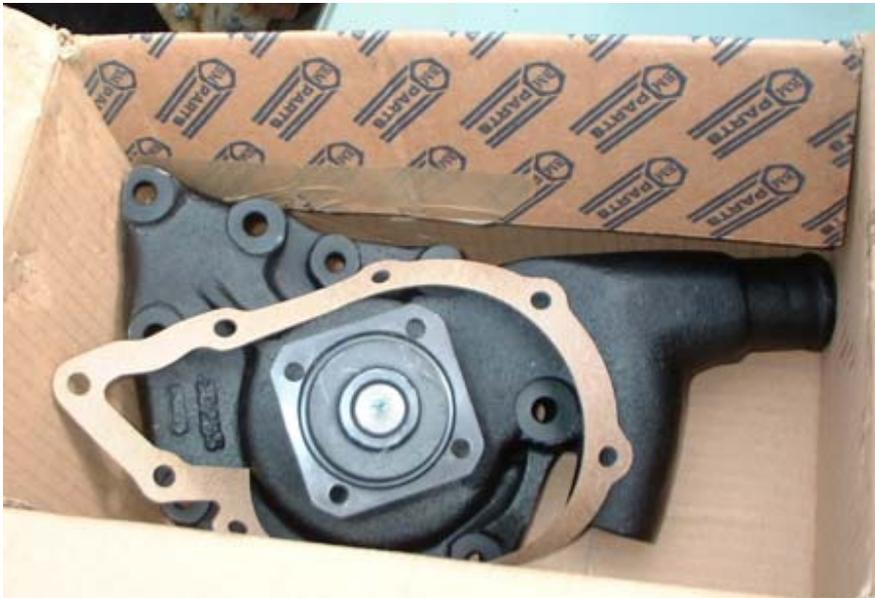
and had the new one in the box ready to fit.
